**US Army Corps  
of Engineers**

**TECHNICAL REPORT REMR-COS**

**CASE HISTORIES OF CORPS BREAKWATER  
AND JETTY STRUCTURES**

**Report 6  
NORTH PACIFIC DIVISION**

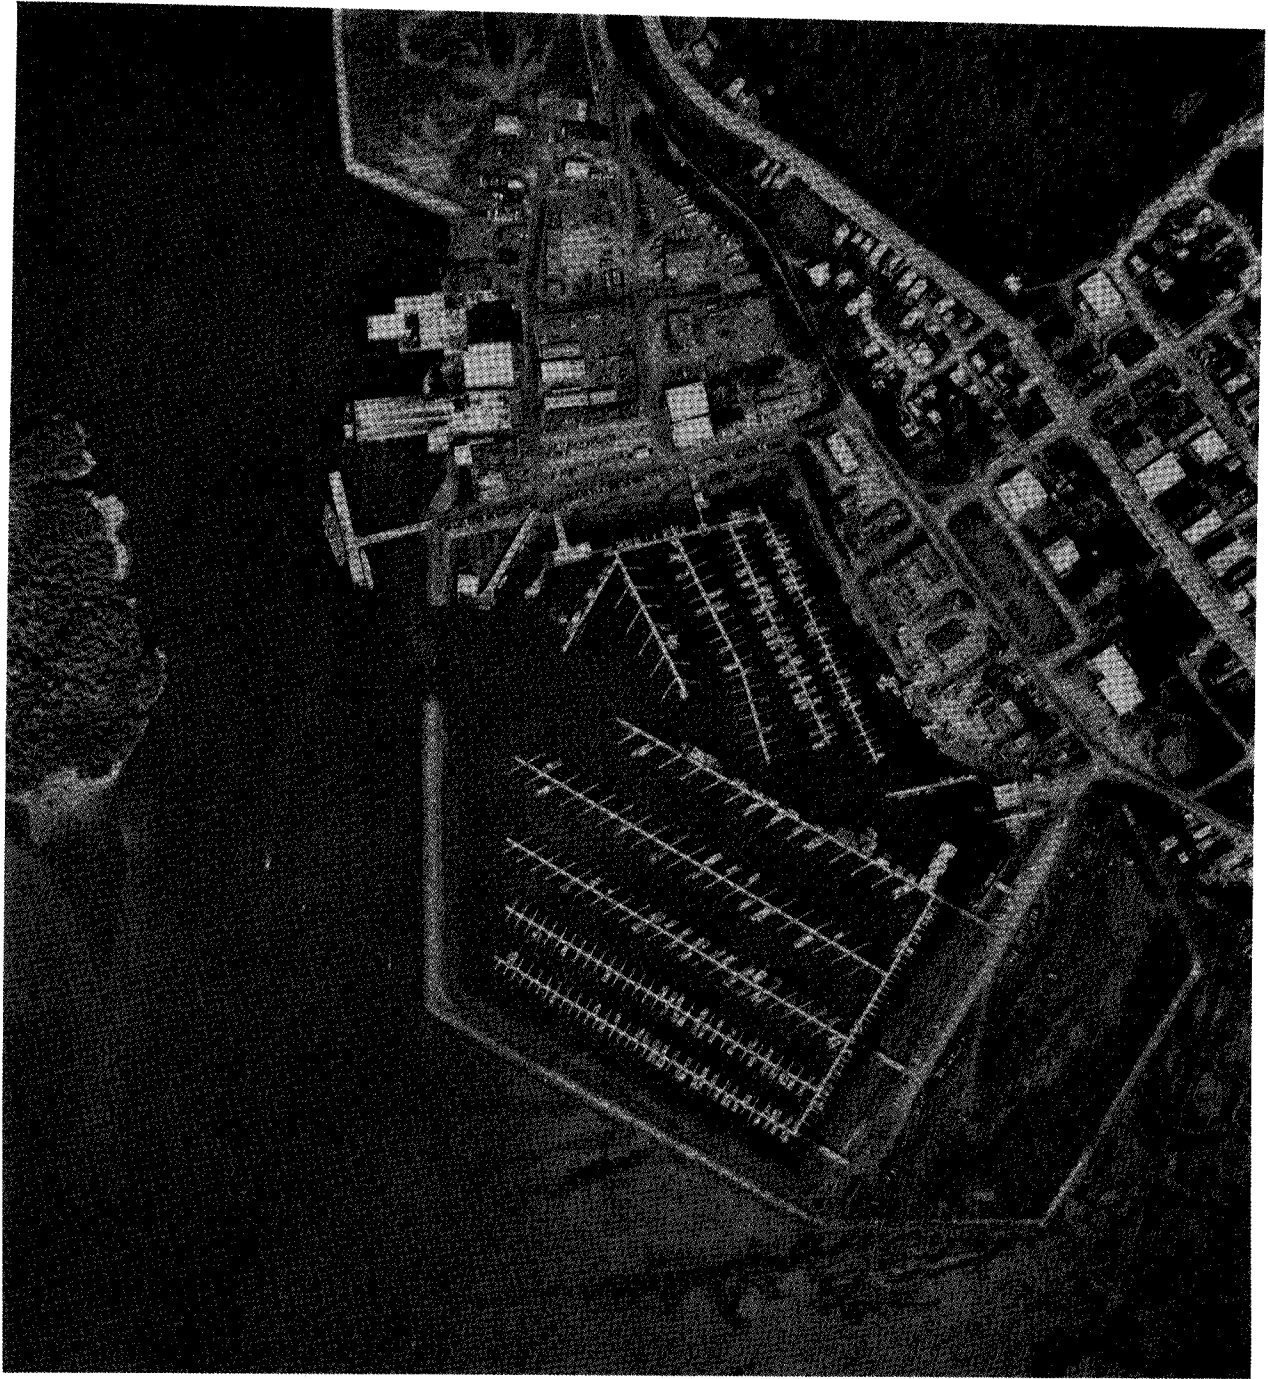
**Figure 6. Aerial photograph of Cordova Harbor, Alaska, 1984**

| Date(s) | Construction and Rehabilitation History |
|---|---|
| 1985 | The harbor is illustrated in Figure 5, and an aerial photograph of the harbor is presented in Figure 6. The breakwaters appear in good condition at this time. |

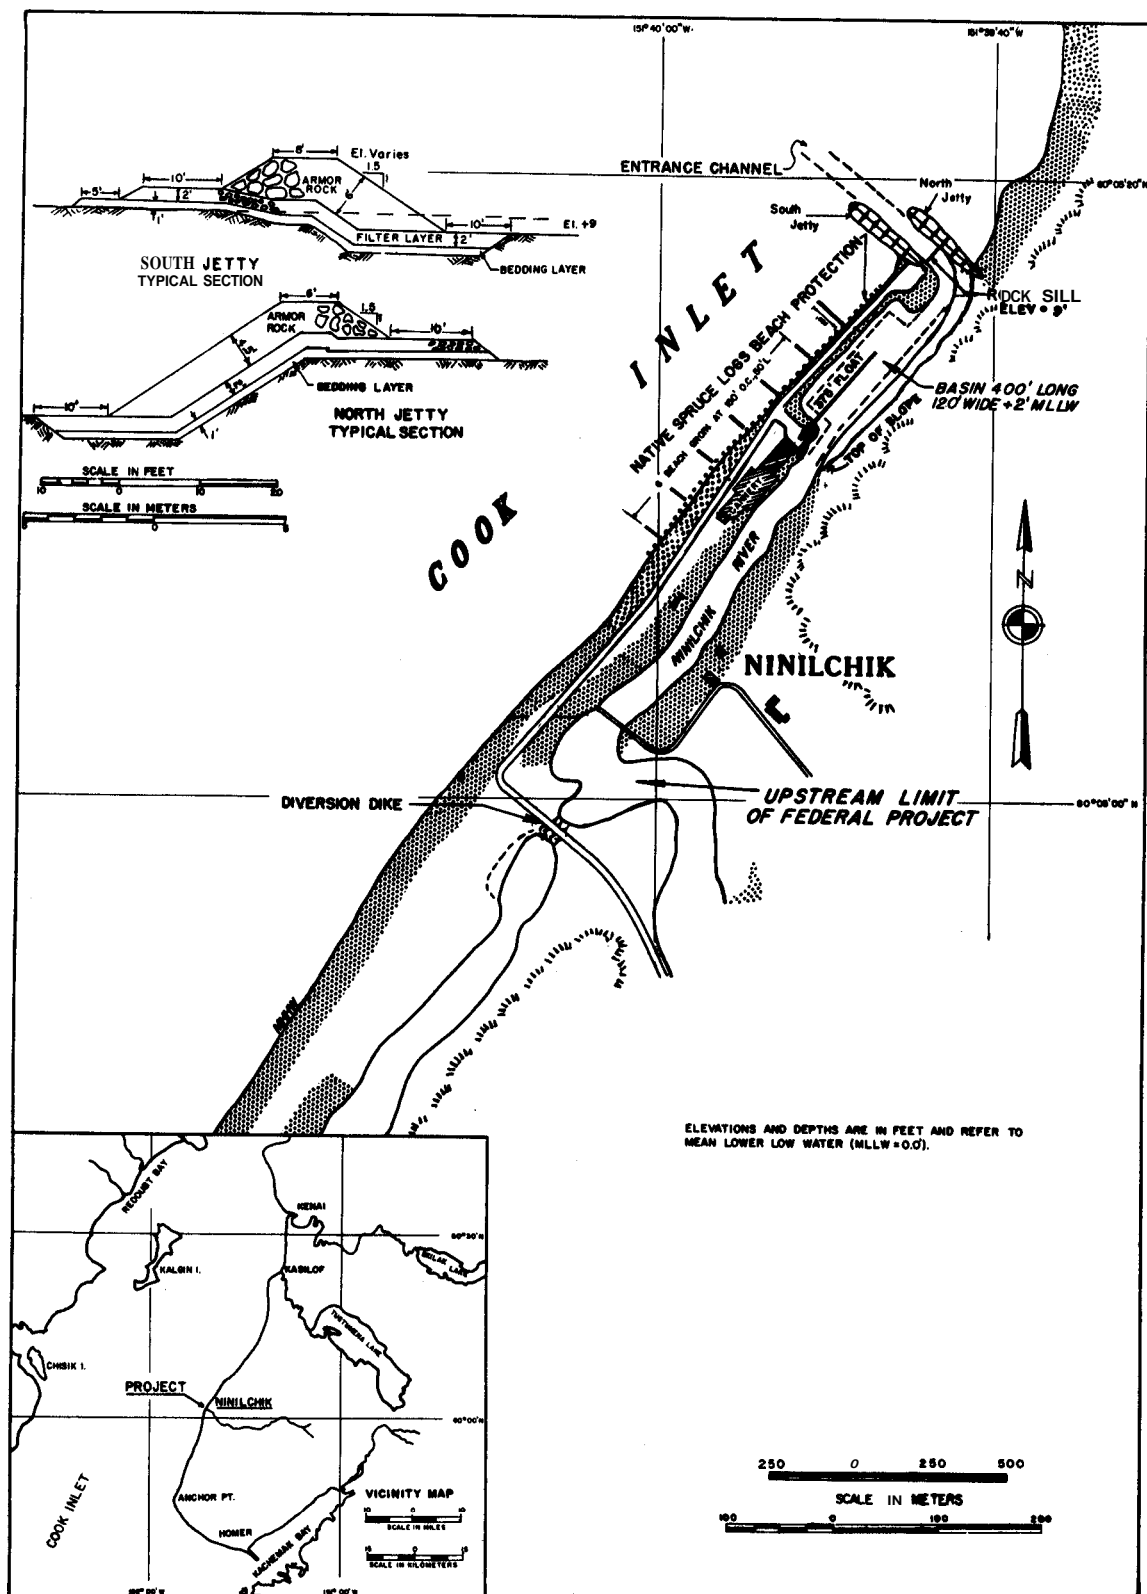
Figure 34. Layout of Ninilchik Harbor, Alaska (revised 1981)

| <u>Date( s)</u> | <u>Construction and Rehabilitation History</u> |
|---|--|
| 1985 | The harbor is illustrated in Figure 34, and an aerial photograph of the harbor is presented in Figure 35. The harbor has required annual maintenance dredging and repairs since its construction. |

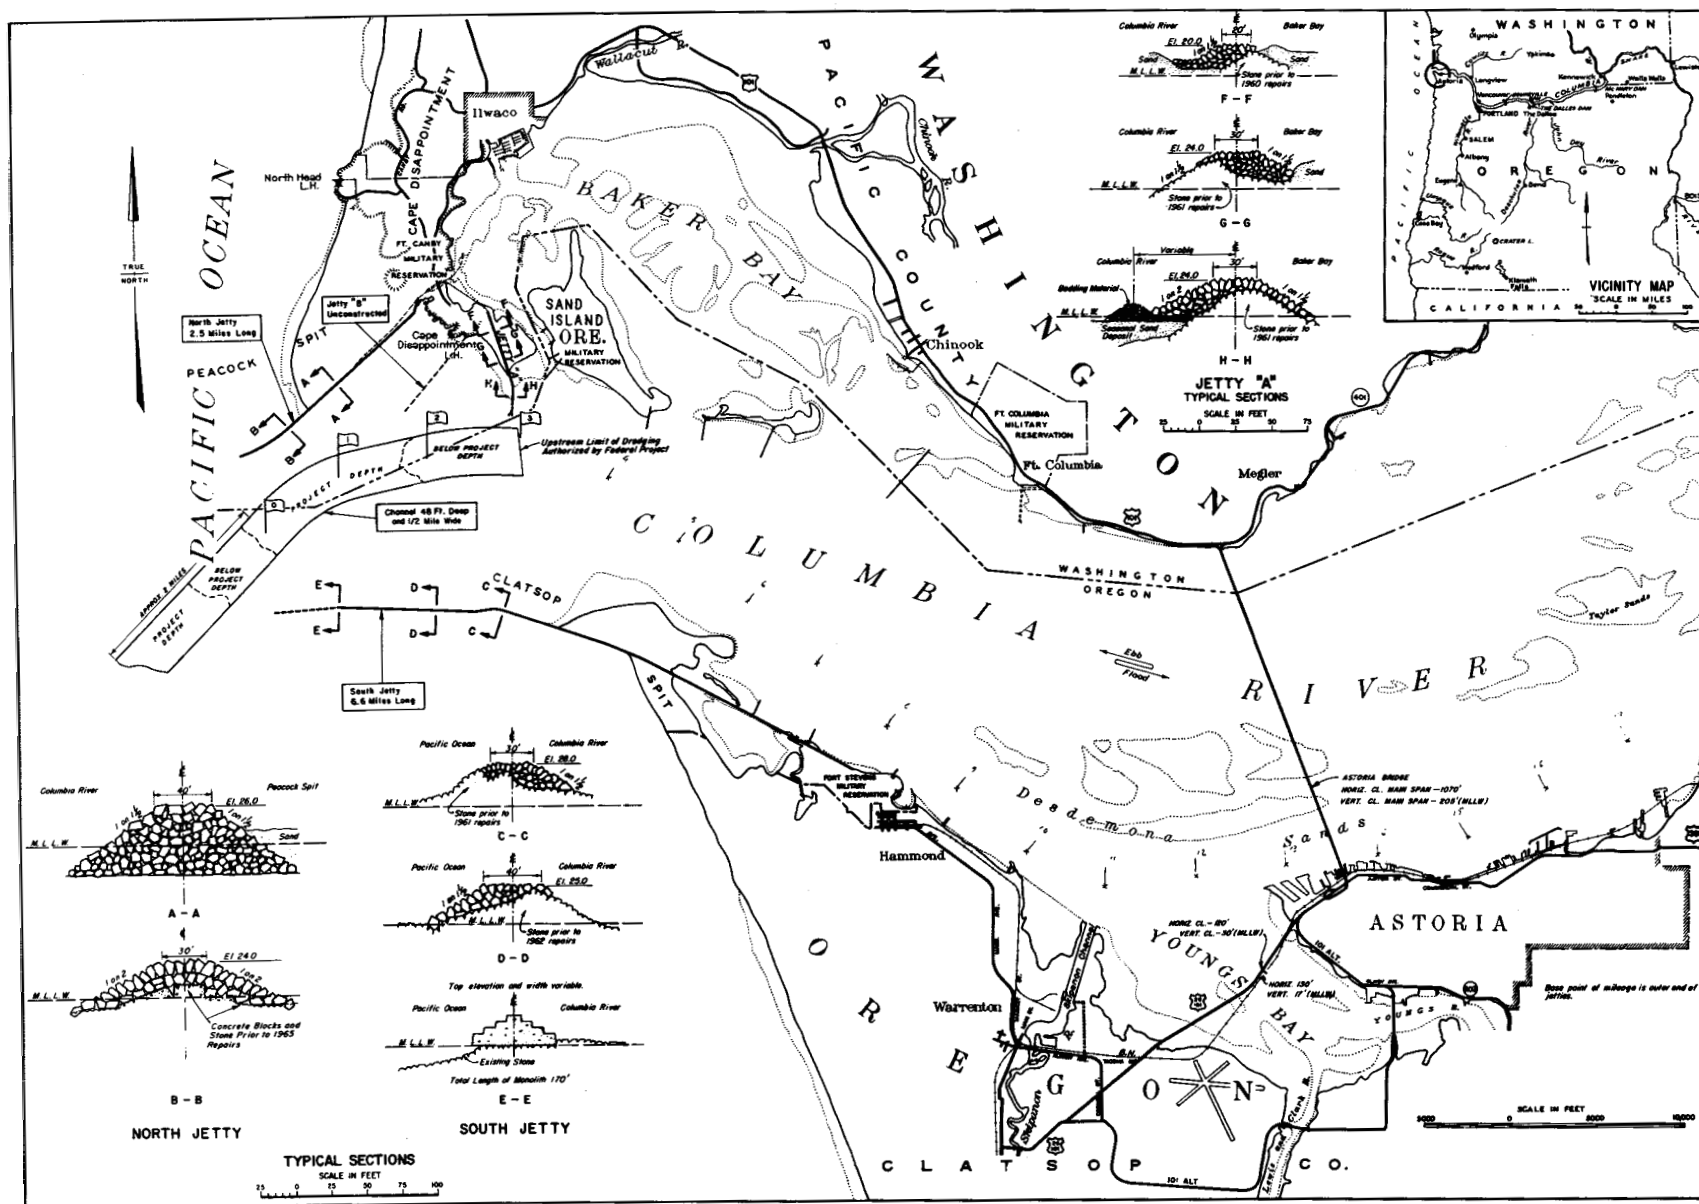
Figure 53. Site layout of Columbia River at Mouth, Oregon and Washington (revised 1979)

| Date(s) | Construction and Rehabilitation History |
|---|---|
| 1985 | The harbor and cross sections of the jetties are illustrated in Figure 53. The north jetty and training jetty "A" have scour problems at the heads. The south jetty is in need of repair. |

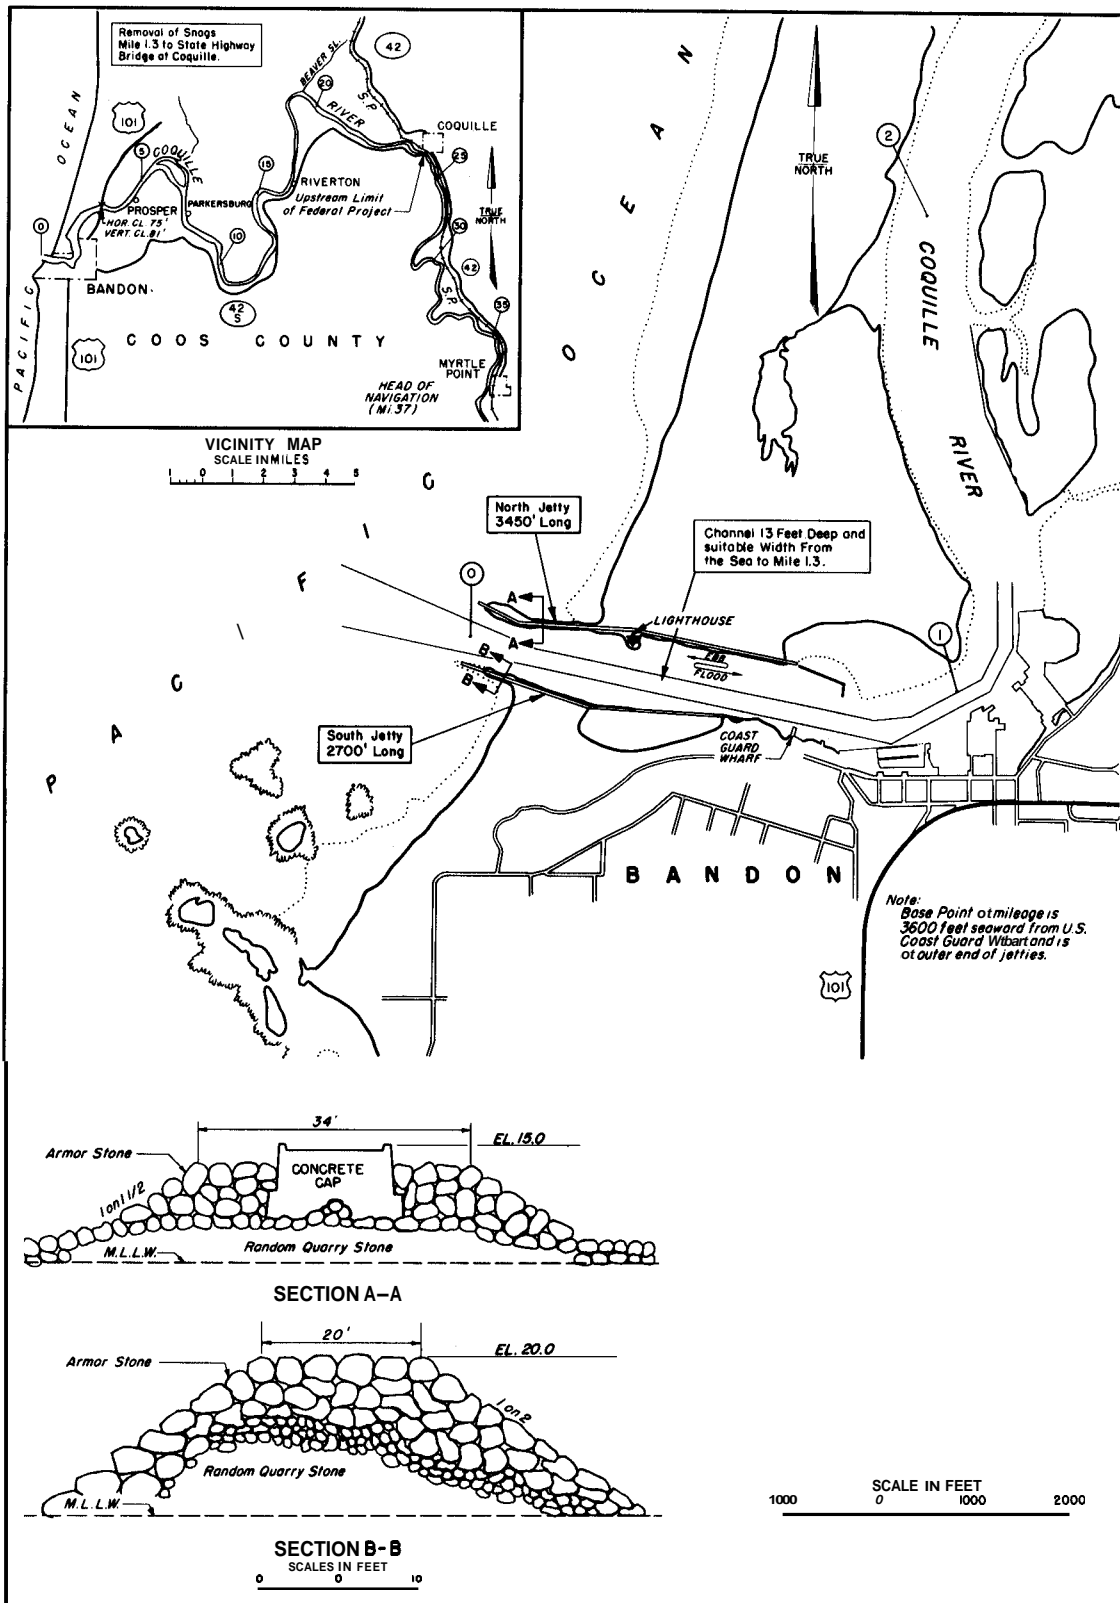
Figure 55. Site layout of Coquille River, Oregon (revised 1981)

| Date(s) | Construction and Rehabilitation History |
|---|---|
| 1985 | The harbor and cross sections of the jetties are illustrated in Figure 55. The head of the north jetty is in need of repair, but it is still functional. The south jetty is in good condition. |

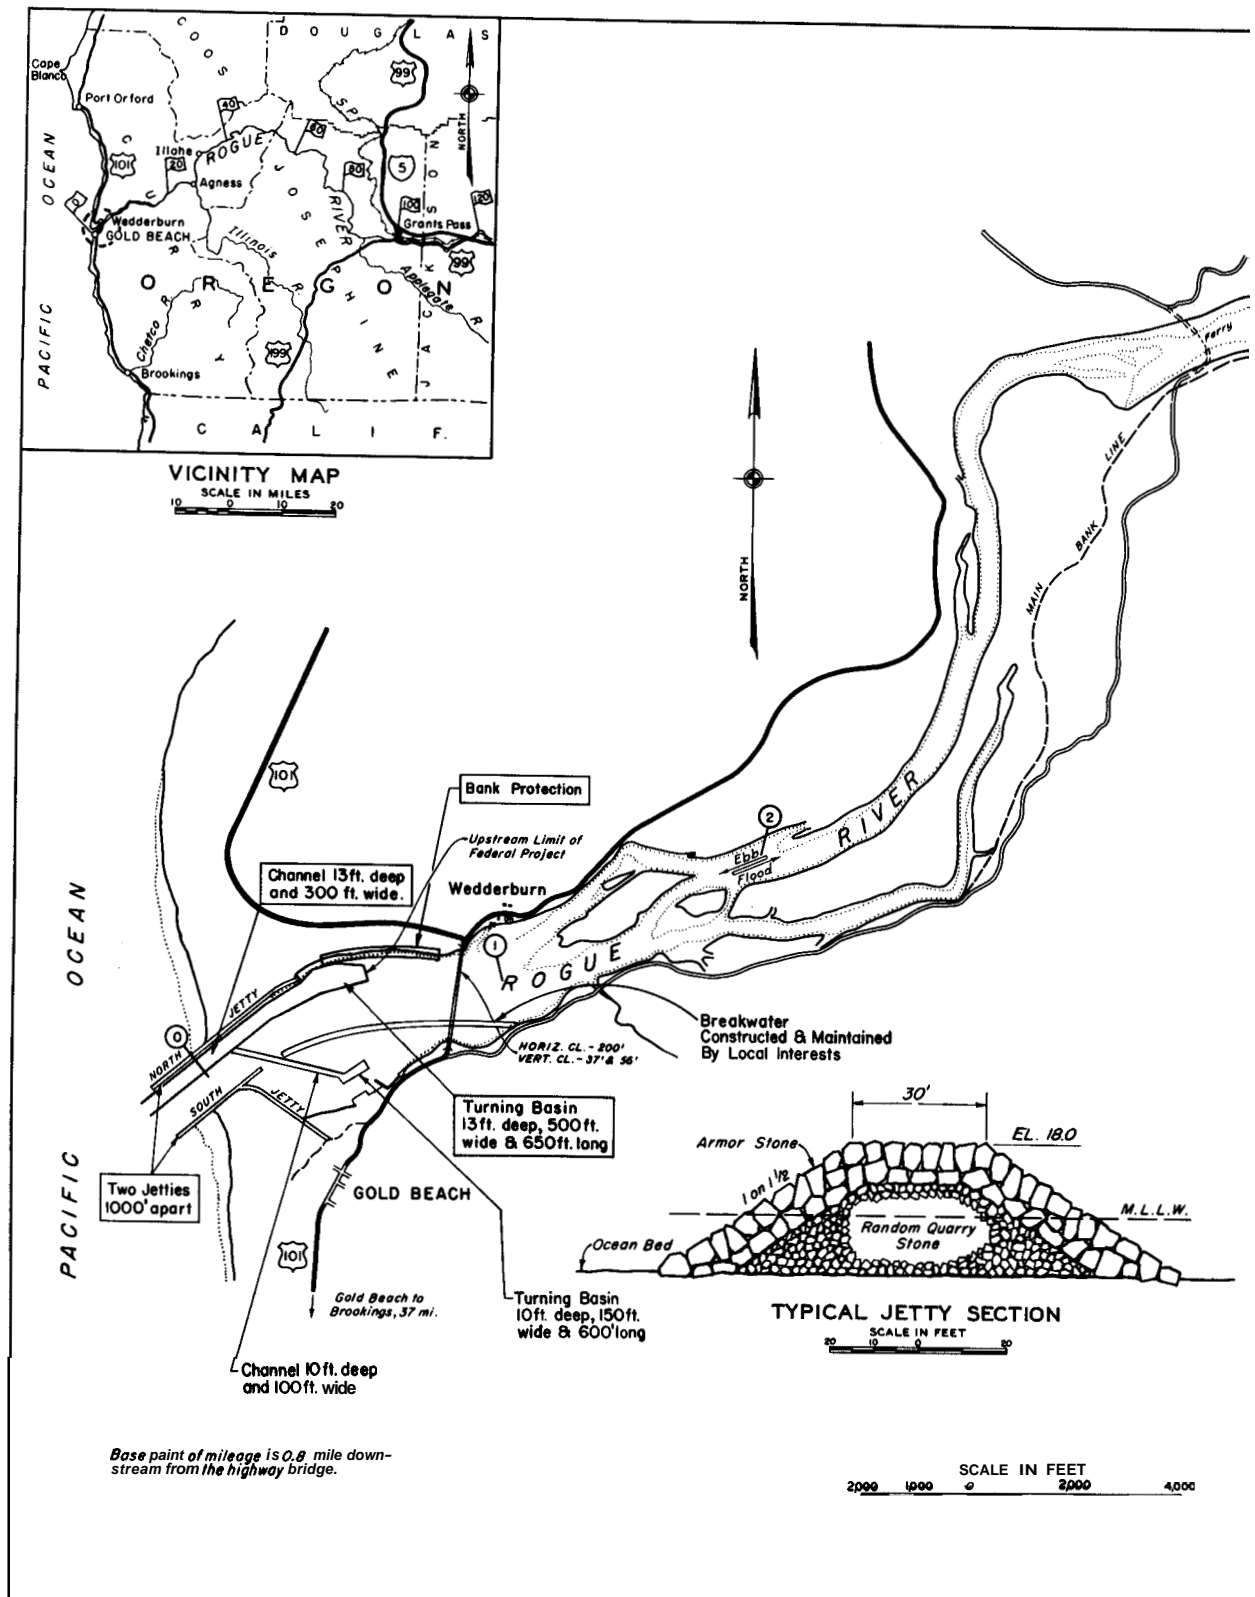
Figure 59. Site layout at Rogue River, Oregon (revised 1977)

| Date( s) | Construction and Rehabilitation History |
|---|--|
| 1985 | The harbor and cross section of the jetties are illustrated in Figure 59. There is some localized damage on the jetties. |

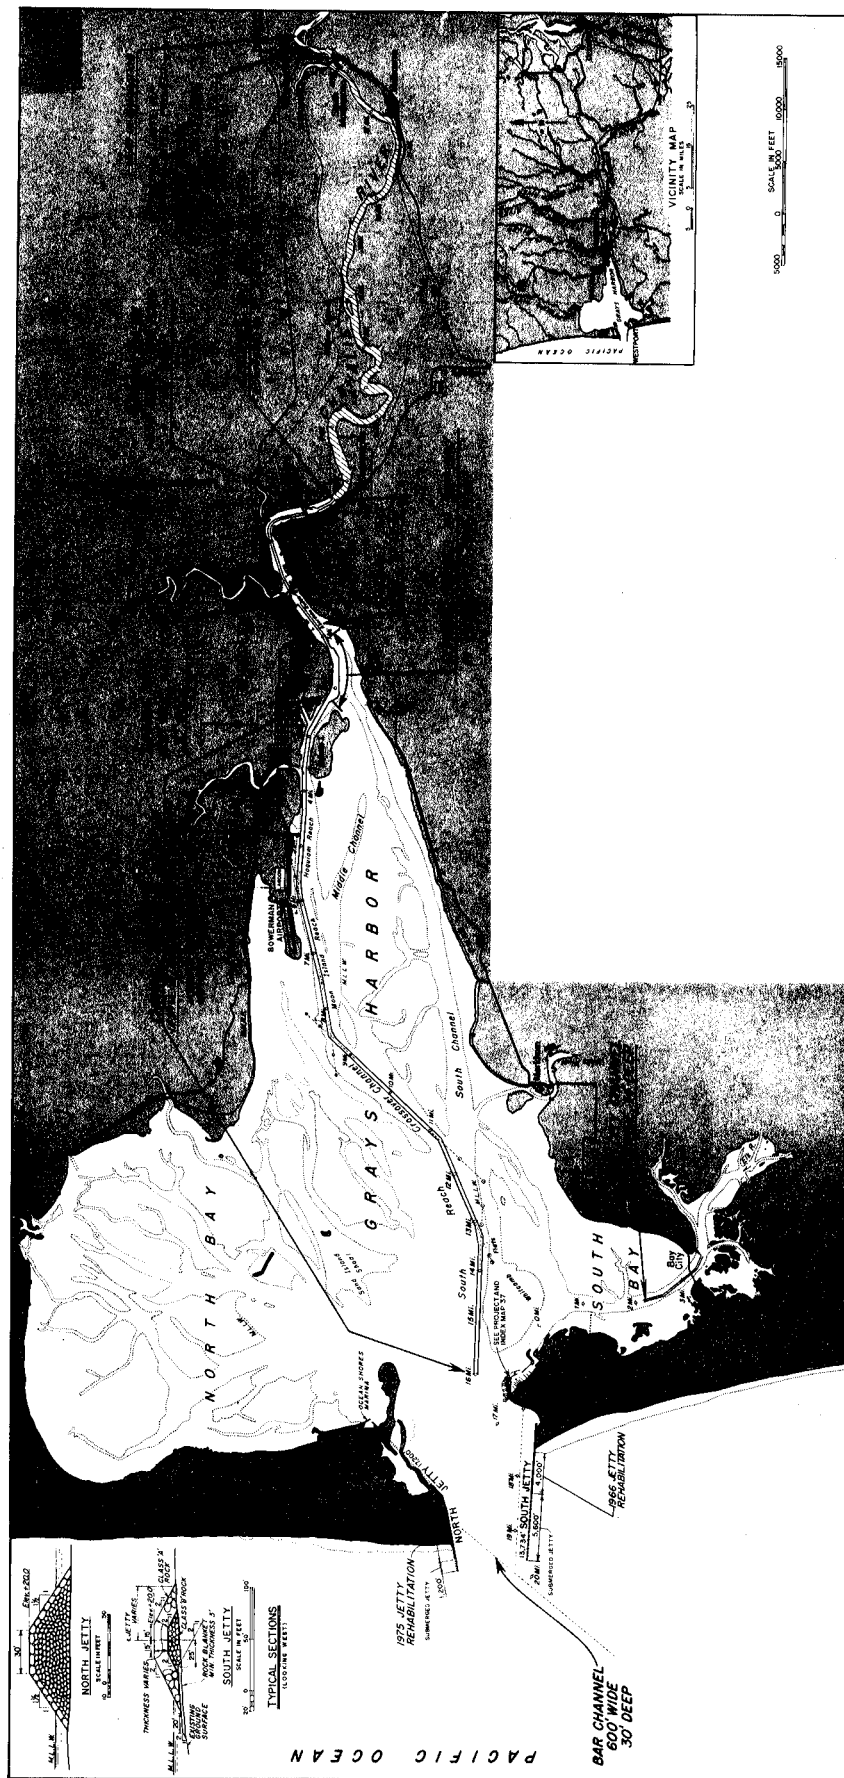
Figure 70. Site layout of Gray's Harbor, Washington

| Date( s) | Construction and Rehabilitation History |
|---|---|
| 1985 | The harbor and cross sections of the jetties are illustrated in Figure 70. The outer 1,200 ft of the north jetty and 5,600 ft of the south jetty are submerged. There is some deterioration of the south jetty, with severe scour along the channel side toe of the jetty. The overtopping conditions on the north jetty in the area of the 1975 rehabilitation work threatens a roadway on the land side of the jetty. |

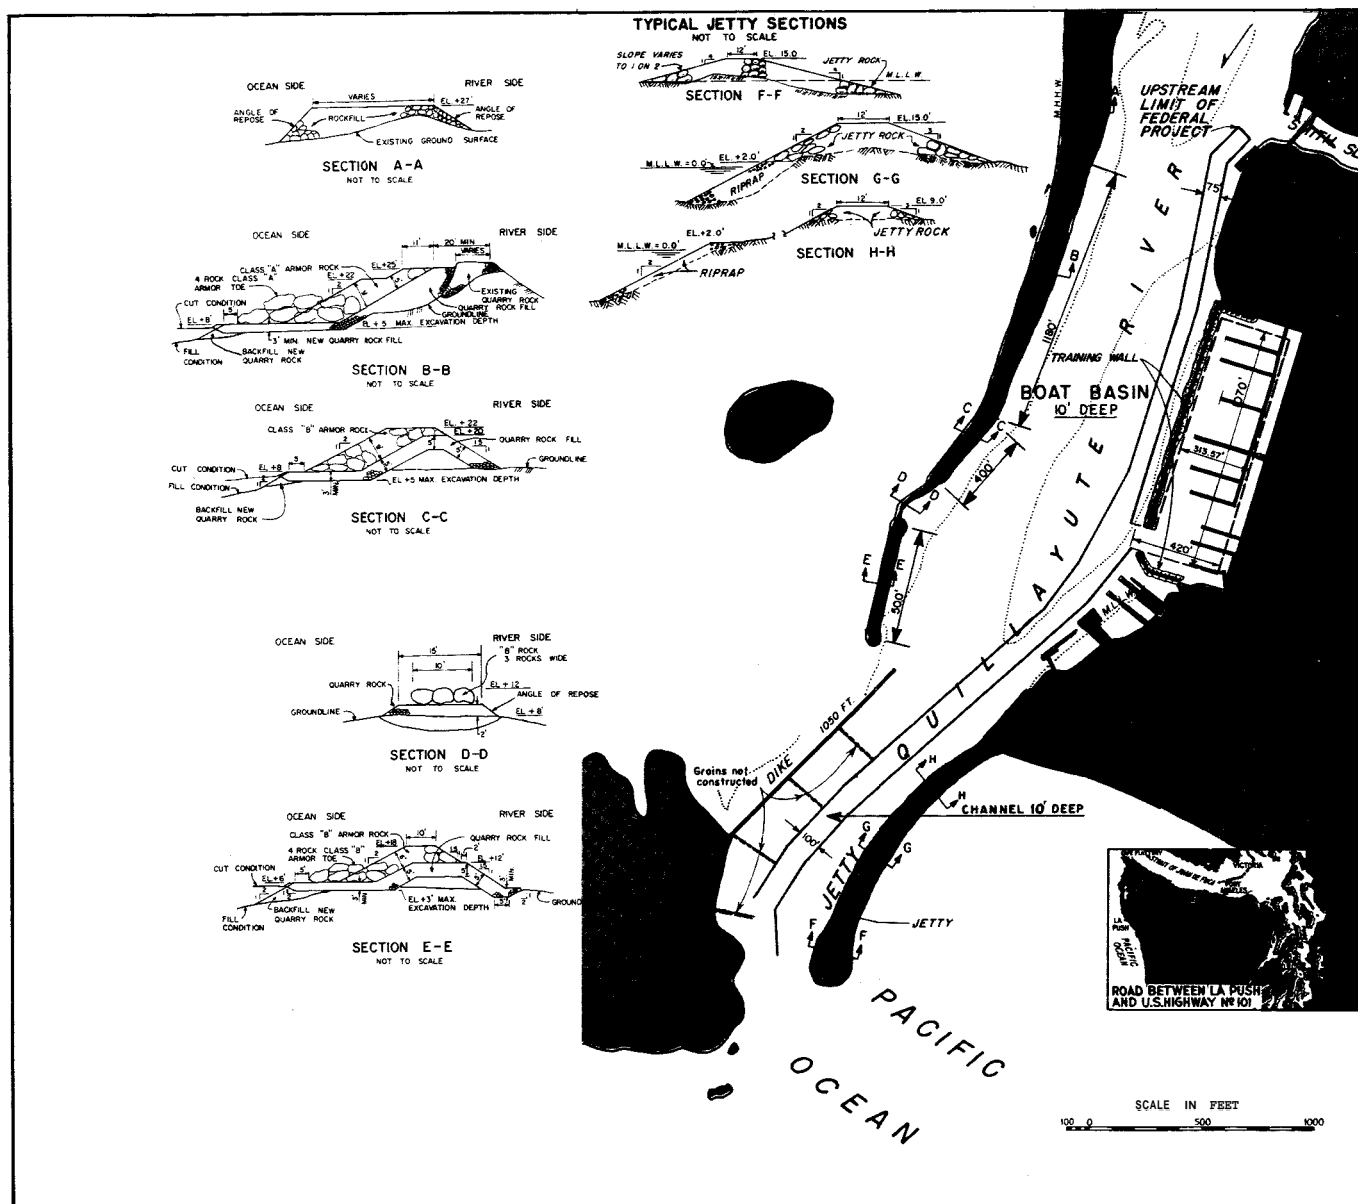
Figure 77. Site layout at Quillayute River, Washington (revised 1982)

| Date(s) | Construction and Rehabilitation History |
|---|---|
| 1985 | The harbor and cross sections of the jetty are illustrated in Figure 77. The outer 250 ft of jetty was lowered to a point that the jetty was awash at high tides. Repair or rehabilitation is not anticipated in the near future. |

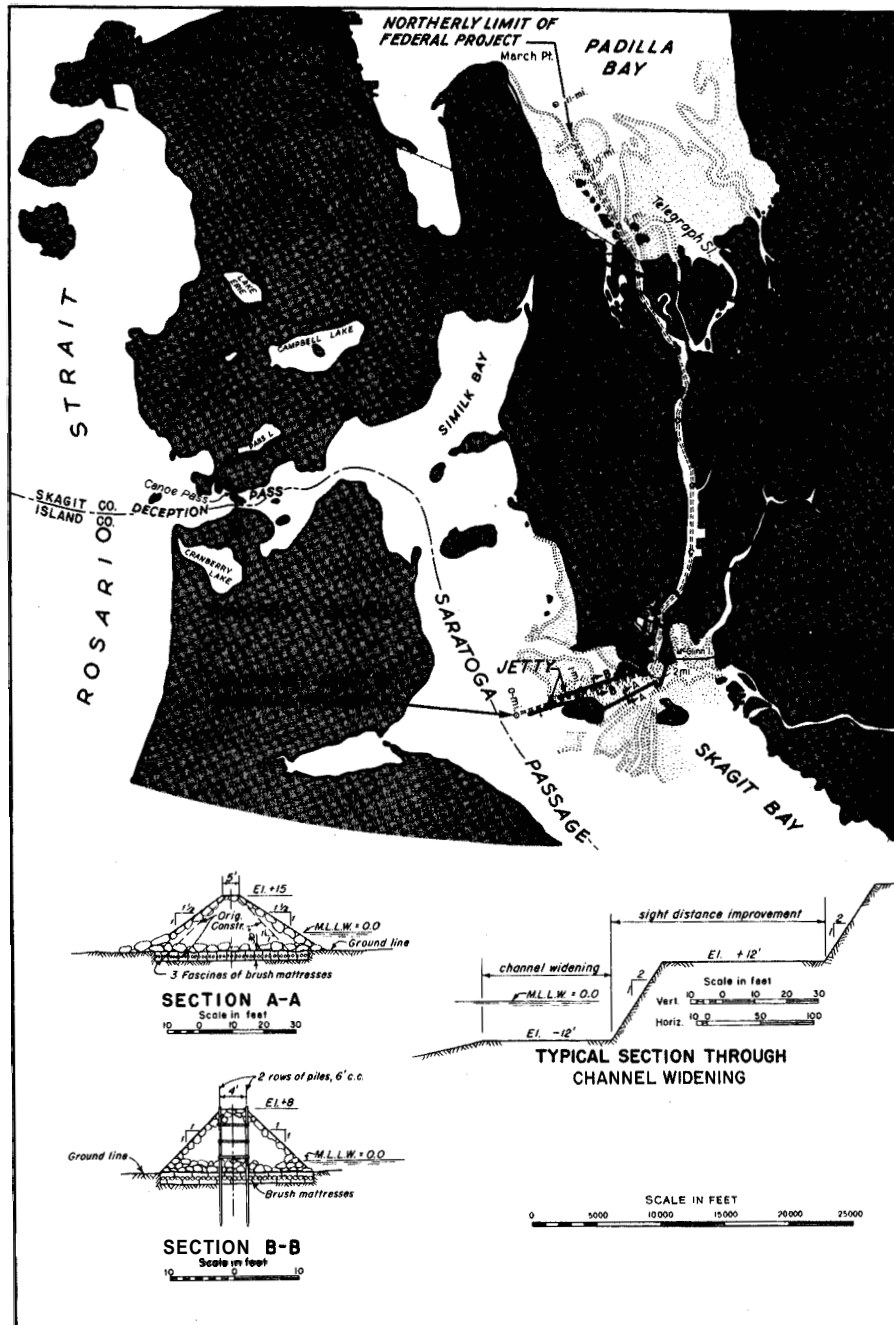
Figure 79. Site layout of Swinomish Channel, Washington (revised 1979)

| Date(s) | Construction and Rehabilitation History |
|---|---|
| 1985 | The jetty layout and cross sections of the jetties are illustrated in Figure 79. The north jetty shows obvious deterioration, and the south jetty and Goat-McGlinn Island jetty appear in good condition. |
